Non-destructive tests of fibre-cement materials structure with the use of scanning electron microscope

The article presents the NDT results of research on the influence of high temperature on the destruction of the structure of fiber-cement board as a result of the failure of a tunnel furnace. Two fiber cement boards were tested. There was a plate in a tunnel furnace during a failure, and reference plate dried in normal conditions. The research used acoustic emission method in combination with artificial neural networks. Interesting research results were obtained, which allowed to observe visible changes in the structure of the tested panels under the influence of high temperature. An important application from the point of view of building practice was formulated.

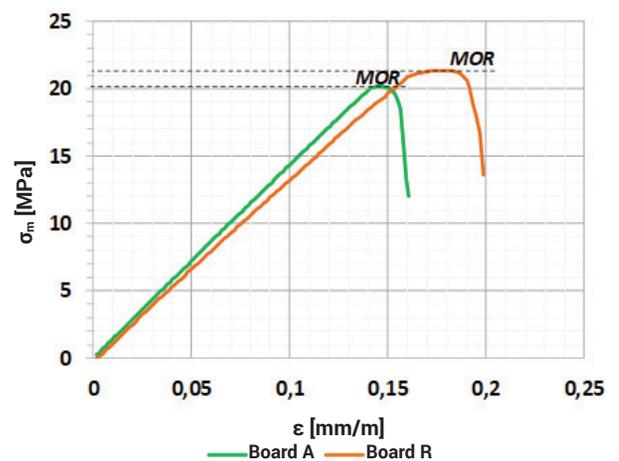
As can be seen by analyzing the results collected in Table I and Figure 3, the difference in MOR bending strength between boards is about 5%, and it can be assumed that it is within the limits of measurement errors. This does not cause any anxiety, but it also does not allow to conclude, whether during the kiln failure destructive changes in the structure

Fig. 3. An example of the dependence of $\sigma-\varepsilon$ for bending on board A and board R

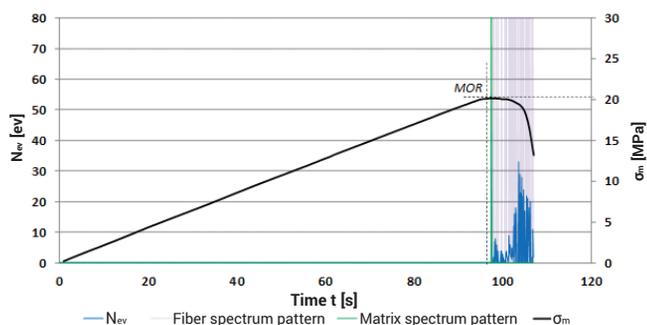
Fig. 4. Recording of the rate of events N_{ev} and bending stresses σ_m in the time function for the board A with the identification of the standard spectral characteristics

From the analysis of Figures 4 and 5 and the results presented in Table II, it can be seen that for board A during the three-point bending test, a significantly smaller number of events occurred in the cracking of fibers by approx. 30% compared to the board R. It can therefore be concluded that due to the failure of tunnel kiln, which caused a high temperature effect, the structure of the fiber-cement board has been destroyed. This destruction involves the burning of part of the fibers and thus the change of technical parameters of the fiber-cement board.

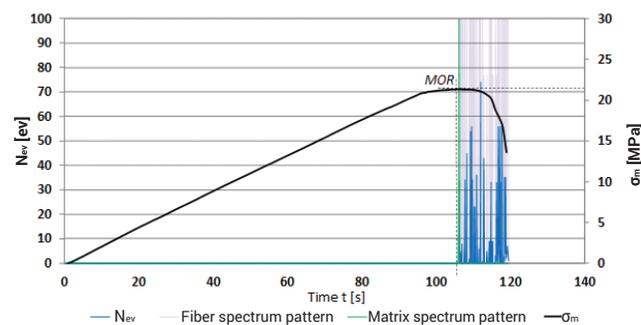
Fig. 5. Recording of the rate of events N_{ev} and bending stresses σ_m in the time function for the board R with the identification of the standard spectral characteristics
