Characteristics of changes occurring on the surface of thin-walled elements as a result of spot welding

Abstract: The paper presents the results of metallographic examination of a sleeve from a refrigeration system used in the food industry. On its outer surface, local surface changes were observed. Metallographic and microscopic SEM examinations were performed. It was found that the direct cause of their formation was the use of spot welding to regenerate its inner surface. It led to plastic deformation of the external surface as well as the formation of a layer of oxides with wustite properties.

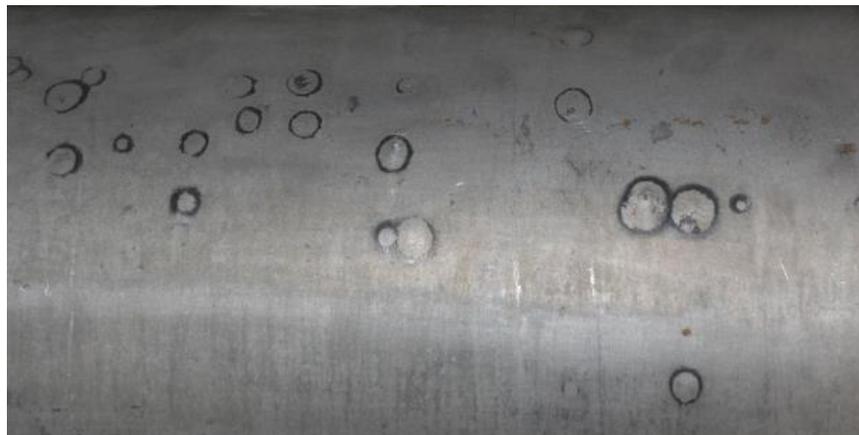
The subject of the research was a fragment of a cylindrical sleeve with a wall thickness of 5 mm, which was part of the ammonia refrigeration device used in the dairy industry. On its internal surface, macroscopic morphology was observed, showing typical features of chromium coatings. The outer surface was characterized by the presence of numerous changes occurring in the form of a dark spherical tarnish (Fig.

1). The outer plane of the tested sleeve cooperated with the second sleeve covered with a chrome coating. The space between them was filled with ammonia as a refrigerant. The presence of changes was observed at the stage of operation, when as a result of mechanical damage on the other of the sleeves it was perforated and refrigerant leaked.

Fig. 1. General view of the outer surface of the sleeve. Visible damage in the form of a spherical tarnish

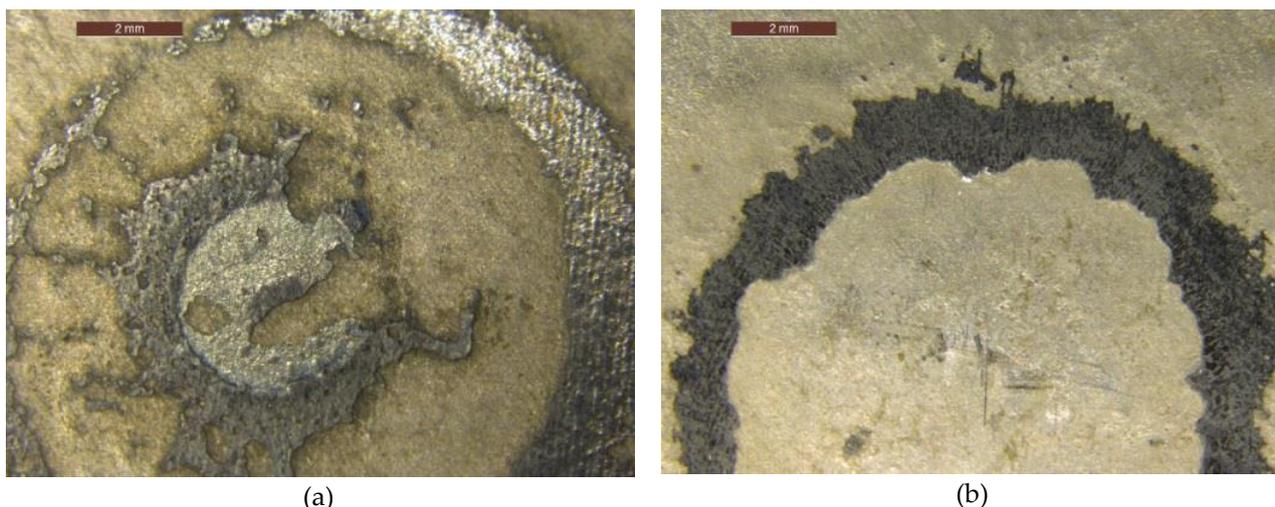
Macroscopic examination of the outer surface at the place of surface changes in the form of a dark tarnish showed the presence of slight protrusions of the surface arranged in such a way that the resulting tarnish was on their periphery. It was characterized by specific surface cracking. In the areas of convexity, mechanical micro-damage of the surface was also found, mainly in the form of scratches (Fig. 2 and Fig. 3).

Fig. 2. Exemplary stereoscopic images of tarnish formed on the external surface: a) tarnish present in the central part of the convexity, b) tarnish present only on its periphery

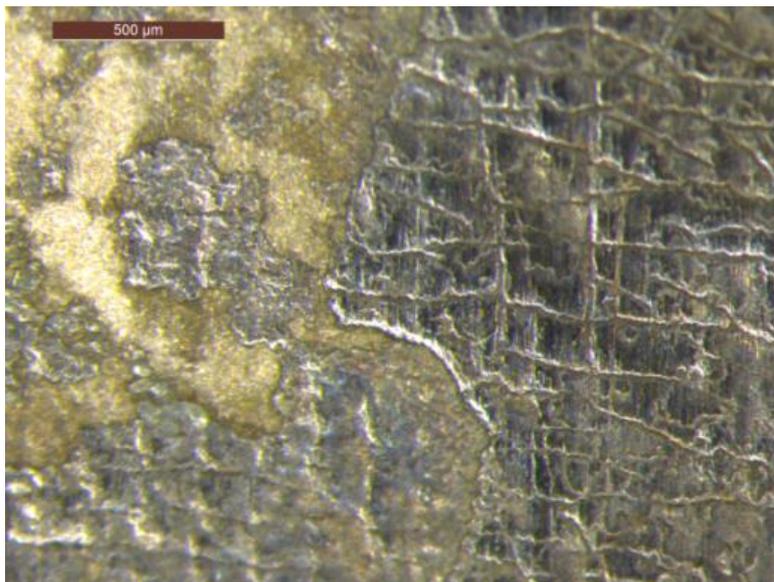
Fig. 3. An enlarged fragment of the tarnish formed on the outer surface. Visible its characteristic cracking. Stereoscopic microscopy

In areas where the formed oxides formed a layer spherically distributed around the circumference of the protuberances, a characteristic morphology was observed, formed by lines crossing at a right angle (Fig. 3, Fig. 7). Such specific cracking of the iron oxide layer on the surface was caused by their significant

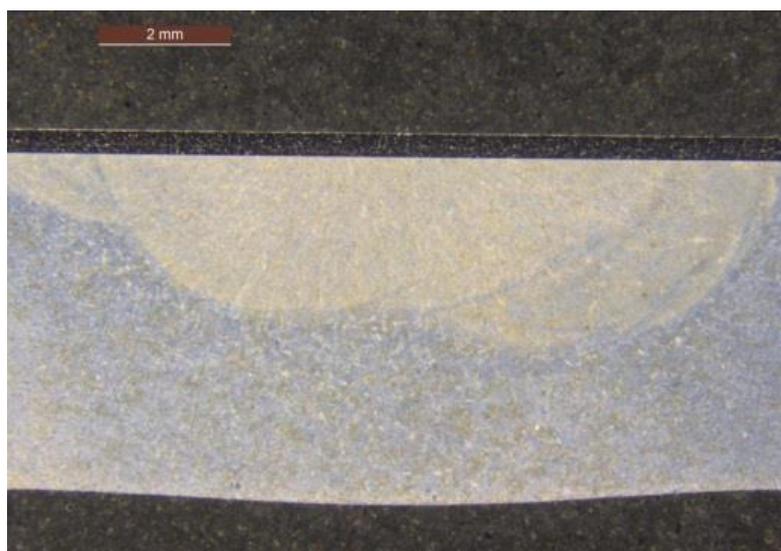
Microscopic observations were made on non-etched specimens made on the longitudinal section of samples taken through the tarnished area. It was found that the chromium coating on the inner surface of the sleeve was 0.35 mm thick. The occurrence of bulges on its outer surface was also confirmed (Fig. 4). Tests carried out after etching the samples with 5% nital showed that at the location of the tarnish and

Fig. 4. Macroscopic image of the longitudinal section made by the sleeve. In the surface area from the inside there are visible further remelting beads and the applied chromium coating, while on the outside side the increase of the section's thickness. Stereoscopic microscopy

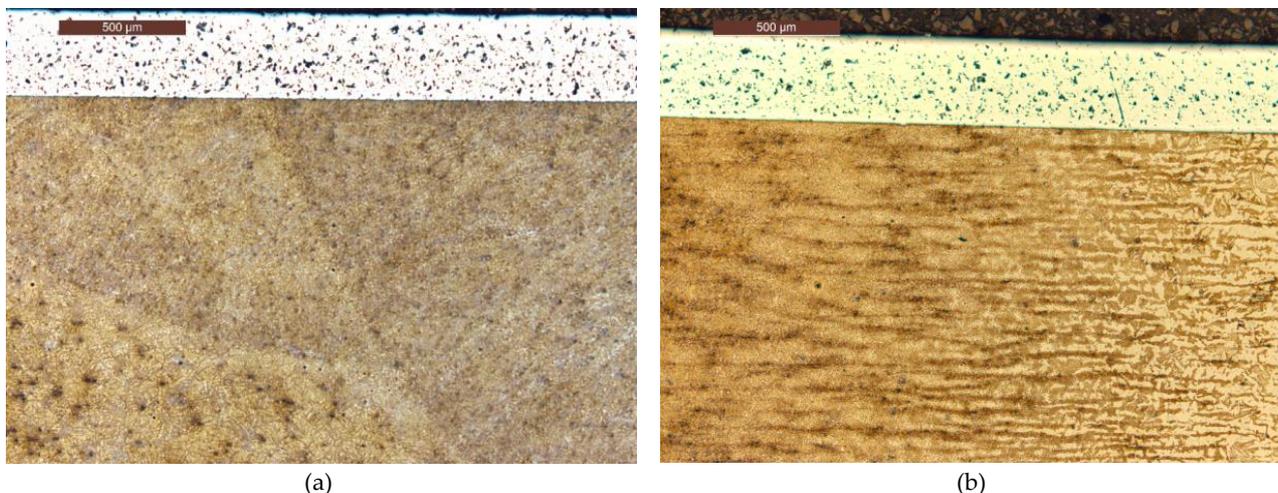
protuberances on the outer surface, there were changes in the macro- and microstructure of the tested material, indicating the surfacing of the pipe from its inside for regeneration (Fig. 5 and Fig. 6). The chromium coating on the inner surface was applied after regenerative surfacing of the sleeve.

Fig. 5. Microstructure of the sleeve in the area of the inner surface: a) visible remelting beads and change of microstructure caused by thermal cycles. A visible chrome coating of 0.35 mm thickness on the surface; b) differentiation of the microstructure in the area of the heat affected zone (left) and native material (right). Light microscopy, etched state

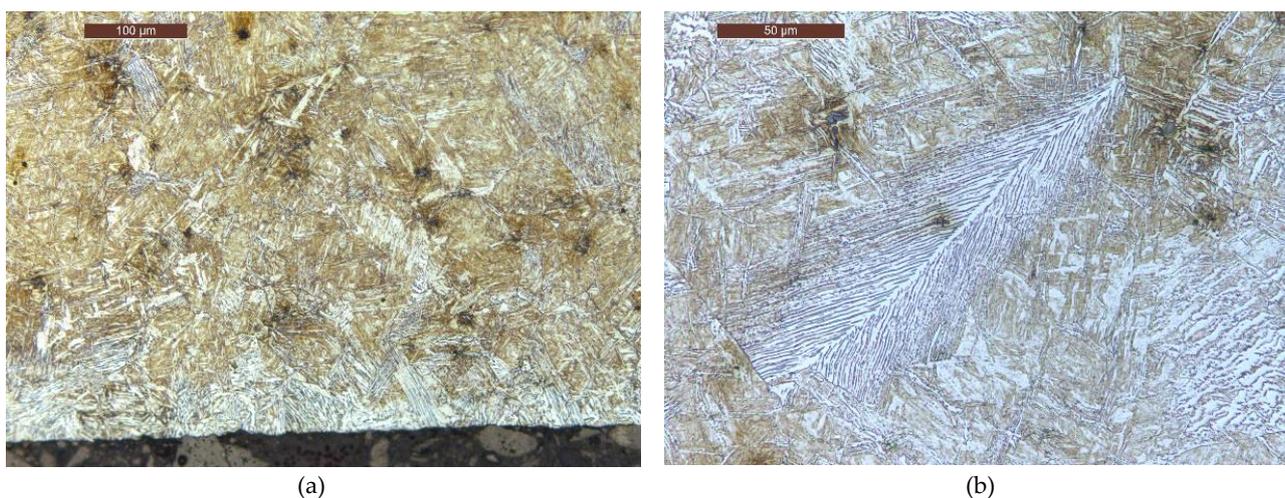
Subsequent thermal cycles affected the multiple phase changes occurring in the surfaced area, which led to the diversity of the material microstructure and promotes the formation of a complex state of stress and deformation in the weld. The microstructure of the native material was characterized by the occurrence of a ferritic-pearlitic structure with features of the Widmanstätten's structure. Structures characteristic for welded areas subject to recrystallization processes were observed in the heat affected zone (Fig. 5). In the surface area from the external surface side, the occurrence of local decarburization zones of the element with local grain growth that was not associated with surfacing was revealed (Fig. 6a). At a short distance from the surface, a microstructure typical for materials hardened as a result of rapid cooling, with local precipitation of upper bainite was observed (Fig. 6b).

Fig. 6. Microstructure of the material in the near-surface area from the outside of the sleeve: a) visible microstructure exhibiting the features of decarburization and non-equilibrium cooling; b) locally visible bainitic microstructure. Light microscopy, etched state

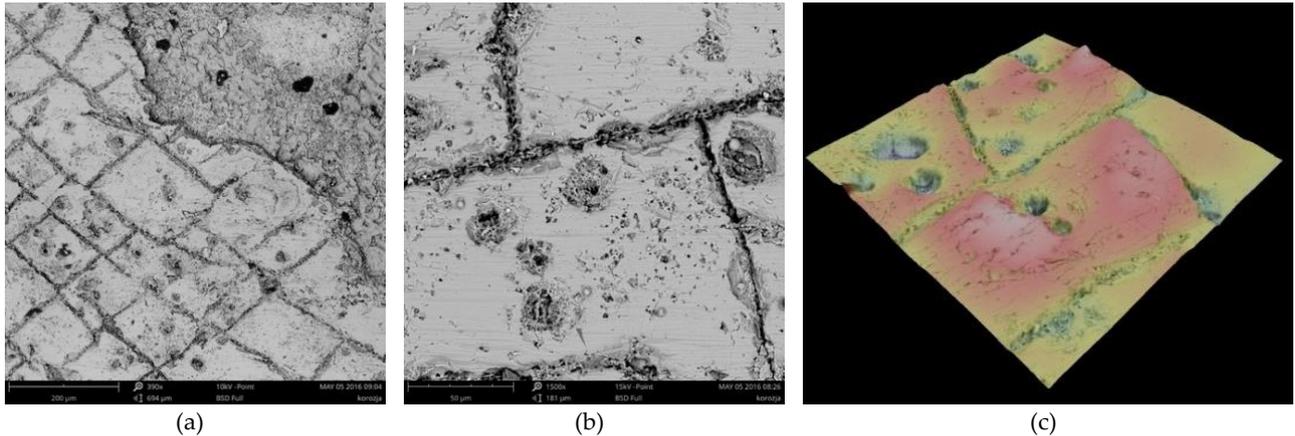
brittleness and tensile stress caused by a plane state of stress generated in the oxide layer. The stresses result on the one hand from different coefficients of thermal expansion of the base metal and this oxide layer, and on the other from welding deformations. A similar nature of cracks caused by residual stress is observed, for example, in the case of chromium coatings [13÷16]. The thickness of the oxide layer formed will depend on the temperature and duration of exposure to the oxidizing atmosphere. Most likely, originally the entire area of induced protuberance was covered with this scale, but they were removed from the surface of the element at the place of protrusion due to mechanical interactions and their chipping. These assumptions confirm the spallings observed in the microscopic image (Fig. 7a). With high probability it can be assumed that in this area there was an increased thickness of this layer, which was conducive to reducing its adhesion to the substrate. This eventually led to the creation of a shallow depression in this area.

Fig. 7. The oxide layer formed on the perimeter of the convexity formed on the outer surface as a result of surfacing: a) visible characteristic cracking of the oxide layer and its mechanical spalling; b) enlarged fragment of the oxide layer; c) topographical 3D image of a fragment of the oxide layer's cracks. SEM

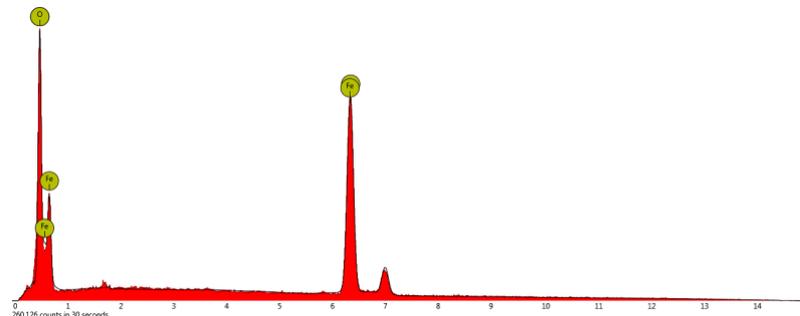
SEM microscopic examinations of the outer surface of the supplied fragment of the sleeve were carried out at the place where the characteristic dark tarnish occurred. As a result, it was found that it is mainly composed of iron oxides (Fig. 7, Fig. 8). Macroscopically, they were characterized by unusual coloring for brown corrosion products (rust) formed in aqueous corrosive environments, which color is mainly given by iron oxide Fe_2O_3 (Fig. 2, Fig. 3). This dark color has a wustite (FeO) in which iron is present in oxidation state II. Its creation indicates that during the surfacing of steel with the simultaneous influence of an oxidizing atmosphere, the temperature in the outer part of the sleeve had to exceed 570 °C. The presence of an oxide layer was found not only in the spherically distributed tarnish on the surface, but also within the area defined by these circles (Fig. 9÷12).

Fig. 8. The characteristic X-ray spectrum obtained from the area shown in Figure 7b indicating the formation of oxide layers in this area

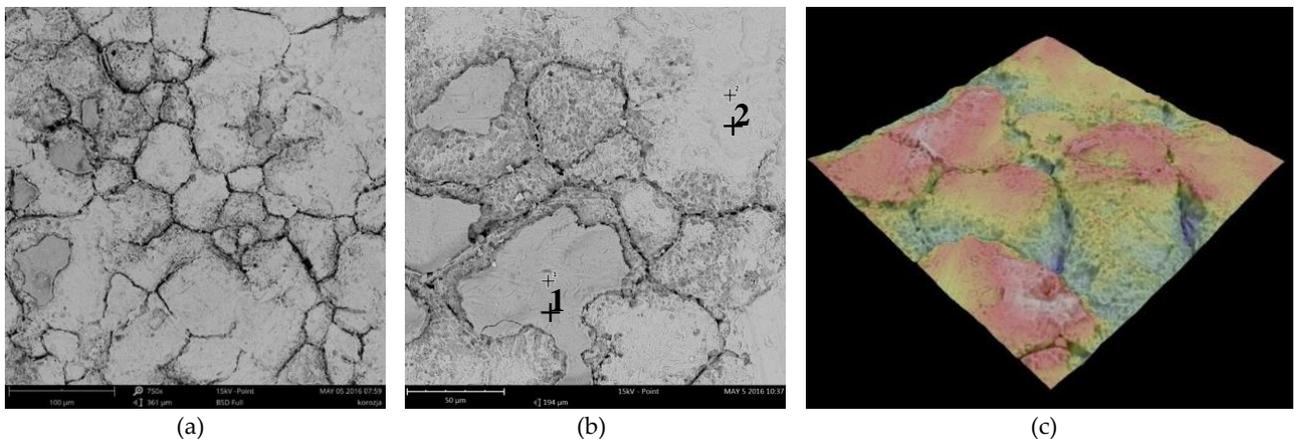
Fig. 9. Microscopic image obtained from the area located in the central part of the spherical tarnish: a) visible oxidation of the grain boundaries and the remains of the unchipped layer of oxides; b) enlarged fragment of the area from Figure a. Points 1 and 2 indicate the locations of the microanalysis of the chemical composition; c) topographical 3D image of a fragment of the oxidation boundary area. SEM

Locally, in the surroundings of oxidation products, changes in the substrate material were observed, which indicated grain boundary dissolution (Fig. 9). Taking this into account, this sample was tested on the longitudinal section, which excluded the occurrence of stress corrosion. It was found that the observed changes located in the central part of the bulge, and thus in the area of temperature increase to the highest values, are associated with oxidation progressing along the grain boundaries. The remains of the oxide layer observed in these areas also confirm earlier assumptions about the presence of the oxide layer also inside the protuberance of the surface formed on the opposite side to the surfaced area (Fig. 9, Fig. 11). An example spectrum of the characteristic radiation obtained from the degenerated oxide layer is shown in Figure 10a, while from the substrate material in Figure 10b. There are significant differences in the intensity of oxygen reflections. The next stages of changes occurring on the outer surface of the tested sleeve are shown in Figure 12.

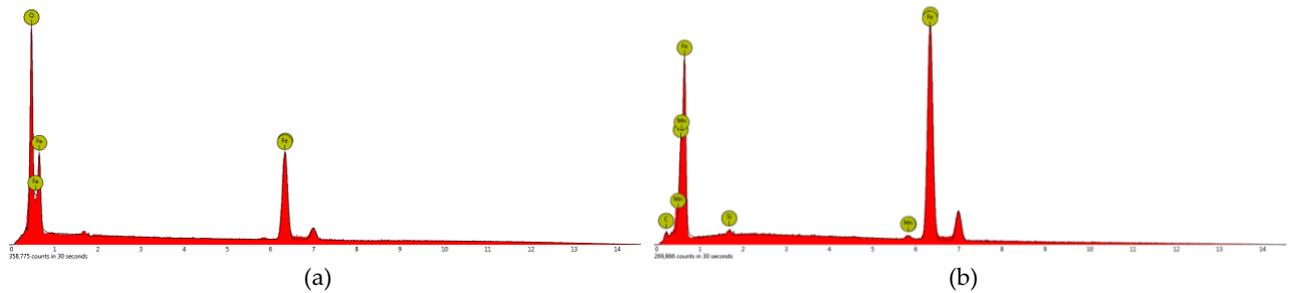
Fig. 10. The characteristic X-ray spectrum obtained from the points indicated in Figure 9: a) point 1 – indicating the presence of residues of the oxide layer formed during the surface deposition on the opposite surface; b) point 2 – in the area of the substrate material

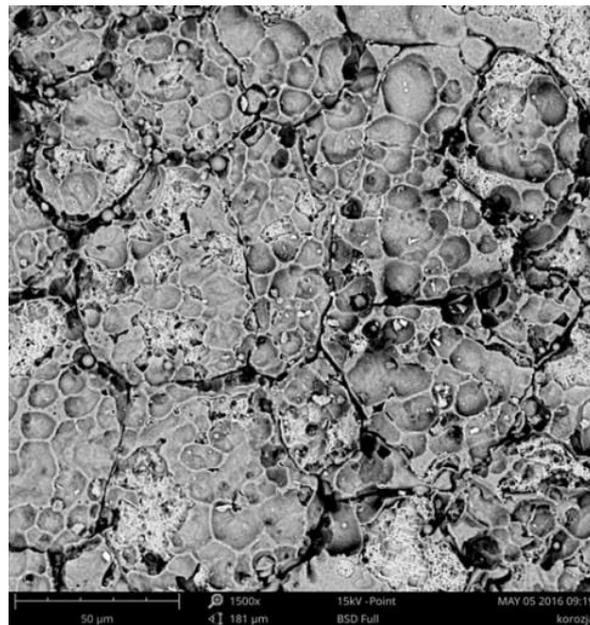
Fig. 11. Microscopic image obtained from the area of oxidation of grain boundaries. The visible layer of oxides formed on the surface. SEM

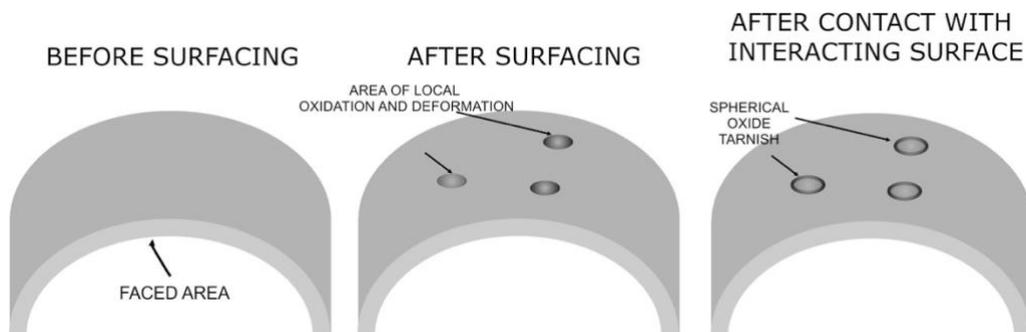
Fig. 12. Diagram of the formation of a spherical tarnish on the outer surface of the sleeve
