Detection of quenching cracks in 100Cr6 bearing steel by the eddy current method

Abstract: The article describes the results of research on the identification and localization of quenching cracks in 100Cr6 bearing steel using a proprietary non-destructive testing device based on the eddy current method called Wirotest M2 and an automatic stand AutoWir-S1. A surface probe with a frequency of 861 kHz was used for the tests. The system recorded changes in voltage amplitude and resonant frequency. A significant decrease in both parameters indicated the presence of discontinuities. The edge effect caused an increase in voltage amplitude and a decrease in frequency, but these changes did not affect crack detection. The smallest detected crack had a maximum width of about 20 µm and was invisible by the unaided eye. The obtained surface charts clearly illustrate the course and localization of individual discontinuities.

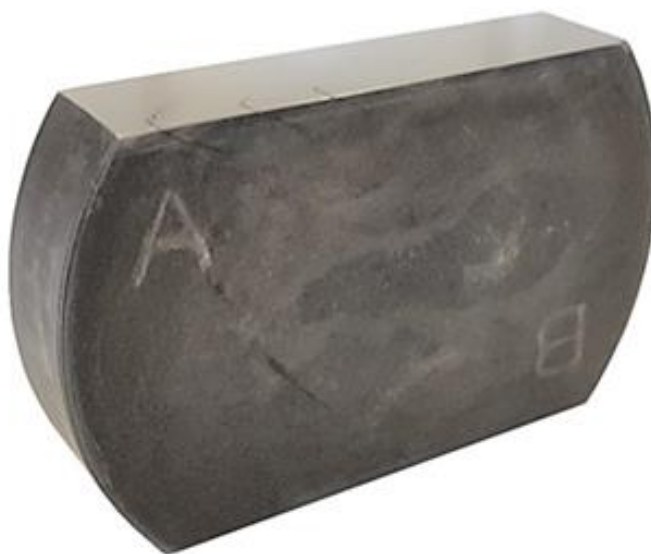
The subject of the research was an element made of bearing steel marked 100Cr6 according to EN (ŁH15 according to Polish Norm) in the form of a disk with dimensions $\text{Ø}47 \times 10$ mm. The element was volume hardened in water at a temperature of 900 °C. The heat treatment was then repeated, increasing the austenitization temperature to 950 °C. The sample was cut in two places to check the presence of cracks on the cross sections marked A and B. The image of the sample after cutting is shown in Figure 1. Observations using a light microscope did not reveal the presence of hardening cracks. Therefore, the element was further processed, in which the austenitization temperature was increased to 1050 °C. Light microscopic observations were repeated. Five cracks appeared on the specimen surface A, similarly to those on the specimen surface B. All cracks propagated from the edge of the sample.

Fig. 1. The sample of 100Cr6 steel after quenching

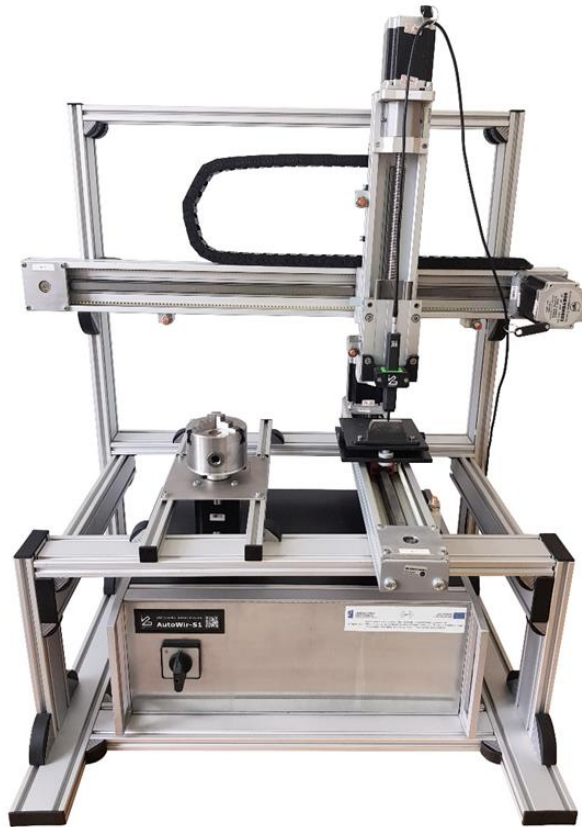
The measurements were performed on the author's automatic AutoWIR-S1 station (Fig. 2) in the flat surface scanning mode [12]. The grid of recorded measurement points during scanning was 0.1 x 0.1 mm. Fig. 3 shows a photo of Wirotest M2 while scanning the surface of the specimen. The holder mounting the measuring device ensured continuous contact of the head with the tested material.

Fig. 2. The stationary automatic stand for non-destructive eddy current testing - AutoWIR-S1

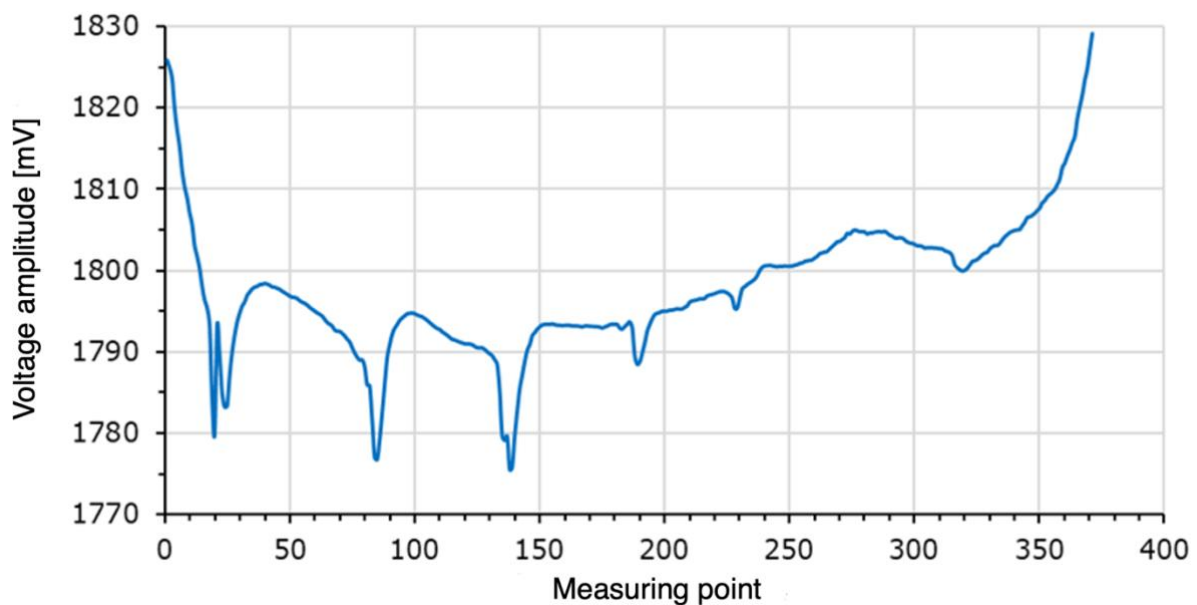
Fig. 6 shows a surface graph of voltage amplitude changes for metallographic image A, while Fig. 7 shows a line graph of measurements taken at a distance of 0.6 mm from the edge of the sample. The edge effect is manifested by an increase in the voltage amplitude of the eddy current signal. However, the presence of a crack reduces the value of the voltage amplitude, which is lower the larger the crack is

Fig. 7. The linear graph of voltage amplitude changes

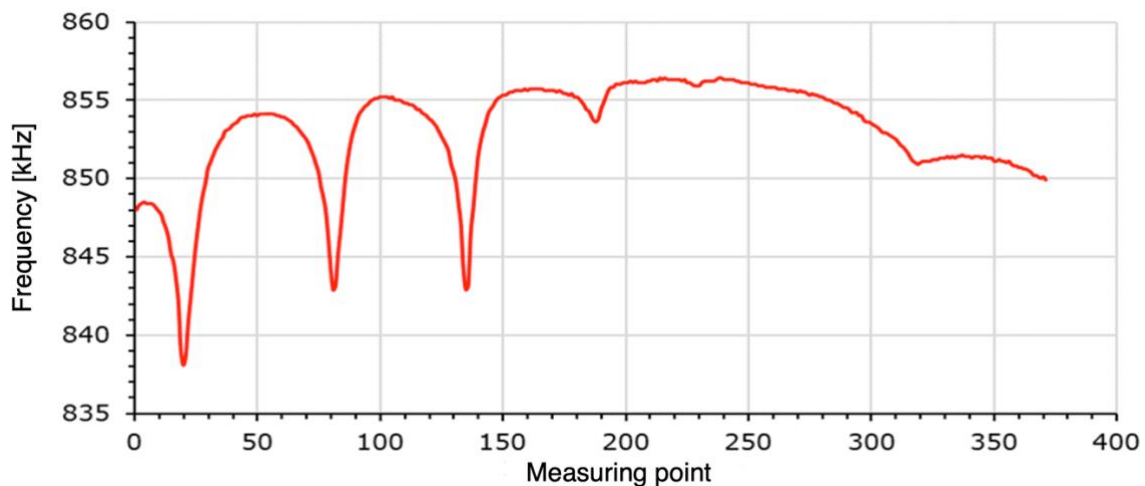
Fig. 8 shows a surface plot of changes in the resonance frequency for specimen A, while Fig. 9 shows a line chart from measurements taken at the same distance from the edge of the sample as in the case of voltage amplitude measurements. In this case, the edge effect is manifested by a reduction in the frequency of the eddy current signal, as is the presence of a crack. The larger the crack, the greater the decrease in its value.

Fig. 9. The linear graph of resonant frequency changes
